Windows Unified Driver User Guide

VeriFone, Inc., <http://www.verifone.com>

Revision 0.1.3

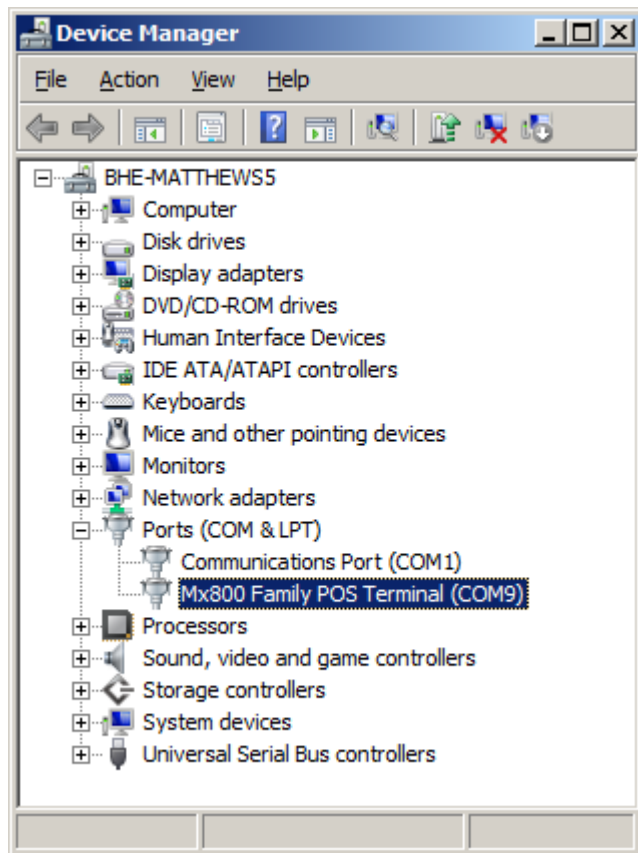
When the system has all this information, and has registered this hardware with the information in the inf file, Devicemanager will look like this:

Depending of course on what device you are using, and what port name and base number was chosen during the install.

At this stage all is good and the application can open that port and begin communicating with the device.

The inf file contains an entry for this hardware ID combination, an associated friendly name for the device, which gets used in place of 'Verifone Mx Gadget v2.4', and an associated service, which is the driver itself.
