Windows Unified Driver User Guide

VeriFone, Inc., <http://www.verifone.com>

Revision 0.1.4

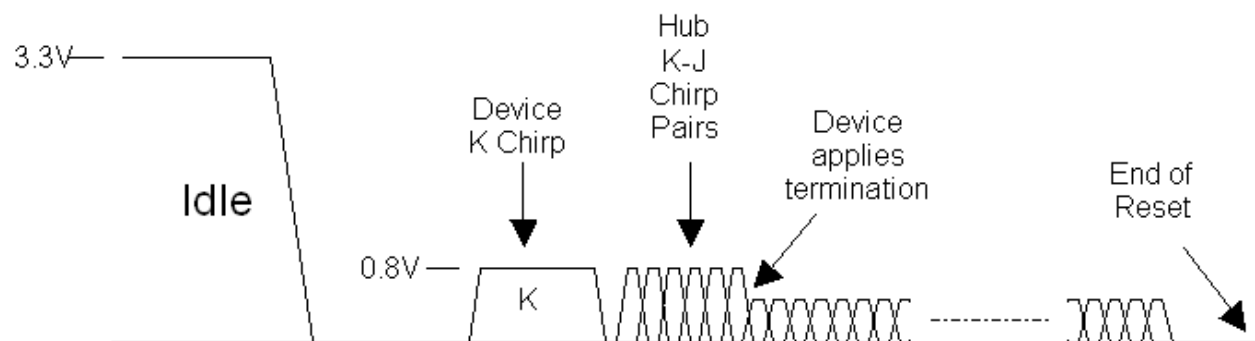
When a USB device is inserted into a host, PC for example, it shows up as a Full Speed device because its D+ line is pulled up to 3volts. To indicate it is a High Speed device, during the mandatory Reset, when the host pulls D+ and D- low, the device applies a lower voltage to the D- line for a period of time. This is called a Chirp-K. If the host is High Speed capable, it sees this, and replies with a stream of Chirp-Js and Chirp-Ks (alternating low voltage on D- and D+). The host copies the device in applying a different resistor to the D+ line resulting in a 500 millivolt differential which is High Speed.
